Inspection Report

219 S Ash
Malvern AR 72104

Date: 2/9/2016	Time:	Report ID: 160209mf3
Property: 219 S Ash Malvern AR 72104	Customer: Ashley Graves	Real Estate Professional:

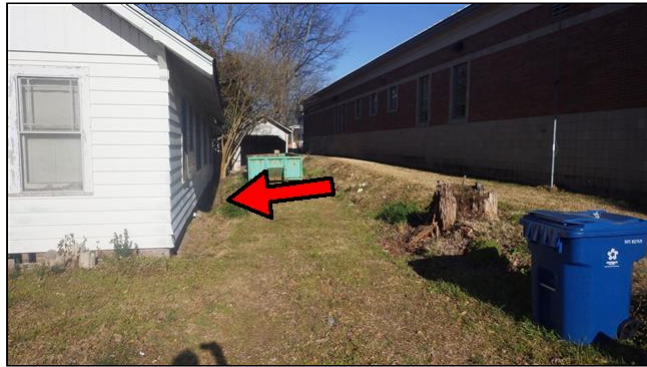
There is a negative slope at the exterior right side (facing front) that can contribute to water intrusion to crawlspace. I recommend monitoring during heavy rain and correcting landscape to drain water away from home if necessary.

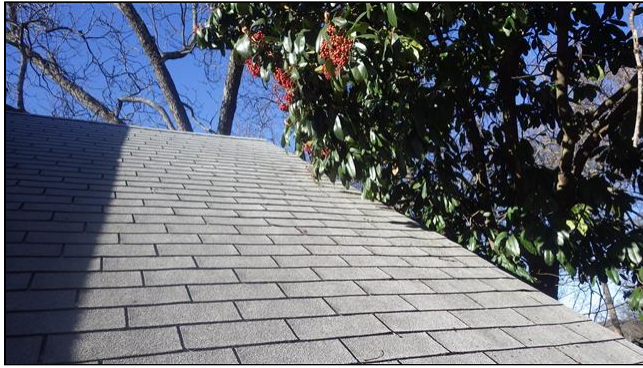
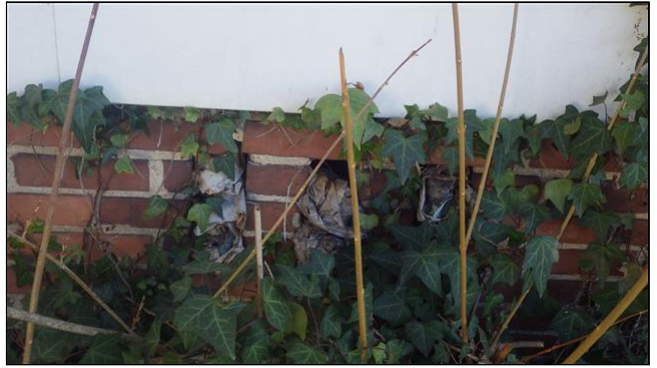
The tree limbs that are in contact with roof or hanging near roof should be trimmed. Limbs can cause damage to shingles and exterior siding. There may be existing damage in these areas (not visible for inspection). I recommend correction using a qualified person.

All vegetation should be cut back at least one foot from exterior siding. Vegetation on or near siding can aid fungus growth and accelerate siding decay. Exterior of home could not be inspected in the areas where vegetation blocked viability. I recommend correct as needed using a qualified person.

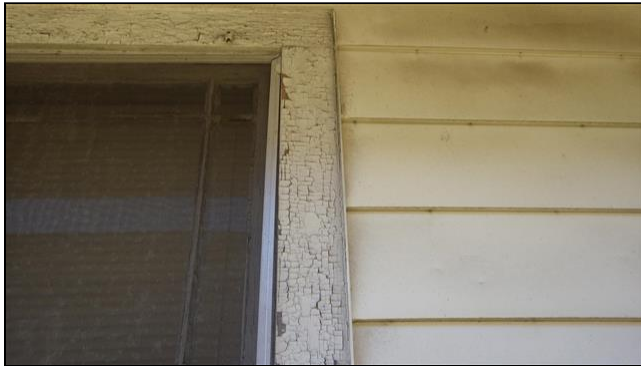
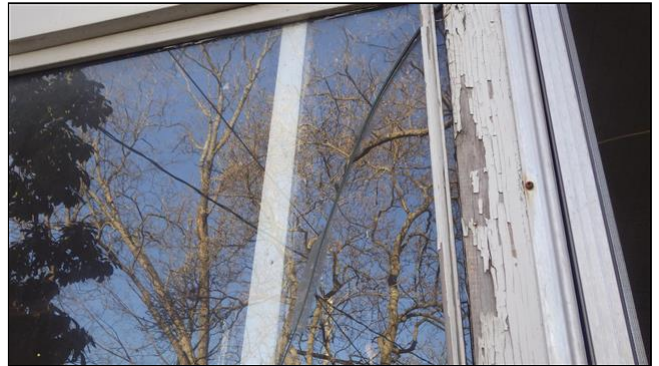
The wood trim is peeling paint at exterior in several areas. Further deterioration may occur if not repaired. I recommend a qualified contractor inspect and repair as needed.

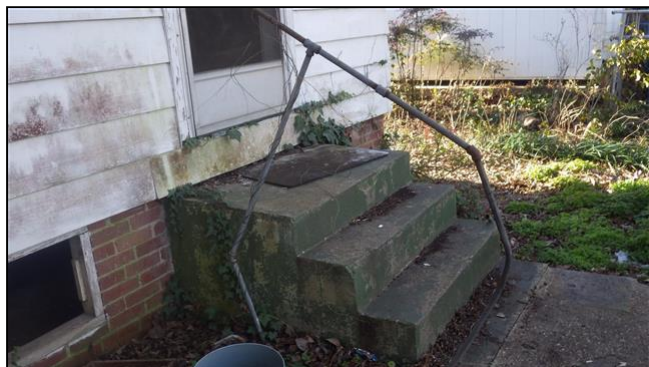
The hand/guard rail is damaged for the steps at the exterior rear of home. A fall or injury could occur if not corrected. A qualified contractor should repair or replace as needed.

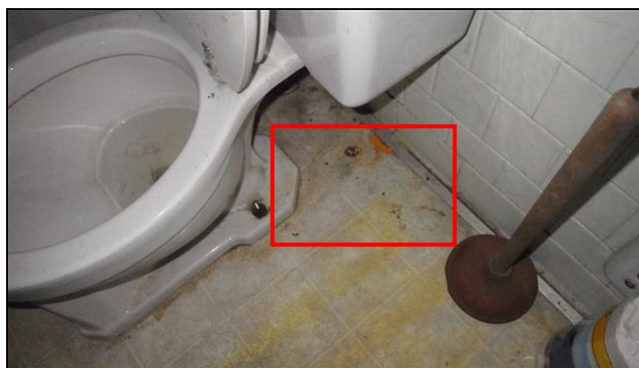
The floor structure appears weak around the bathroom toilet. I recommend further evaluation and correction if needed.

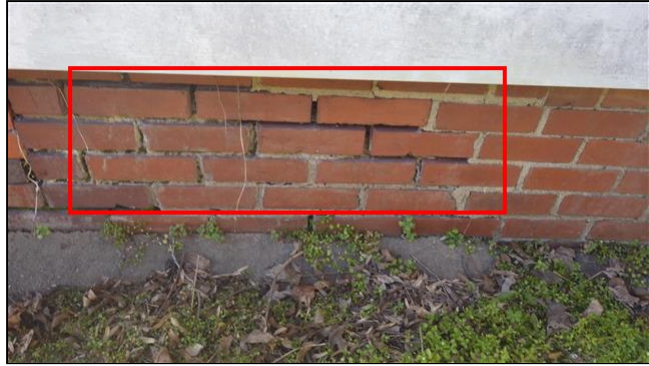
🏠 The brick wall at the exterior right side facing front is missing mortar. This can allow the system to fail if not corrected. I recommend correction as needed using a qualified person.

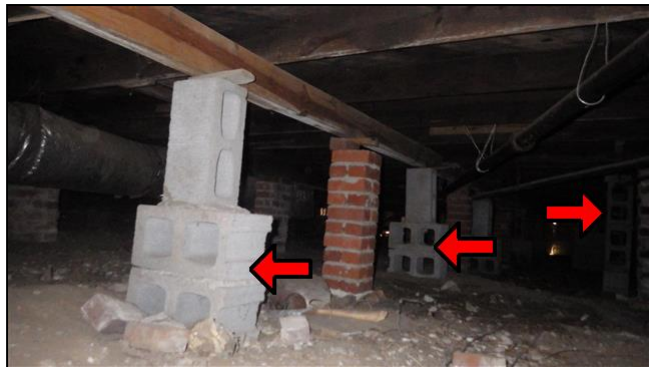
🏠 Cement or Cinder blocks have been installed in crawl space to help stabilize the floor structure. Using dry stacked cement blocks in crawl spaces is not uncommon in older homes but this method does not comply with current building standards for structural repairs/improvements. The open voids (cells) in the blocks are not designed to maintain/support a load. In order to provide proper support the hollow cells on blocks are to be aligned vertically and have a proper footer. Many qualified contractors would consider this a "temporary" repair. I recommend further inspection and correction using a qualified contractor.

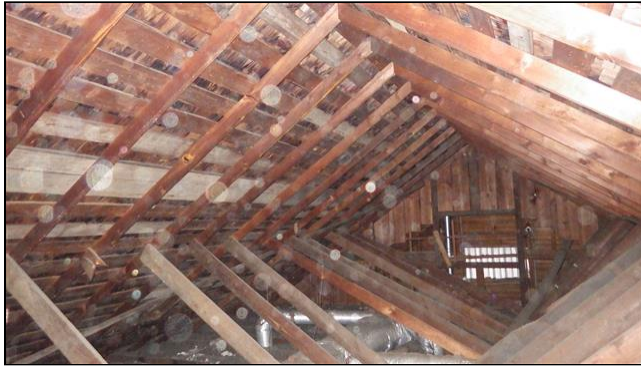
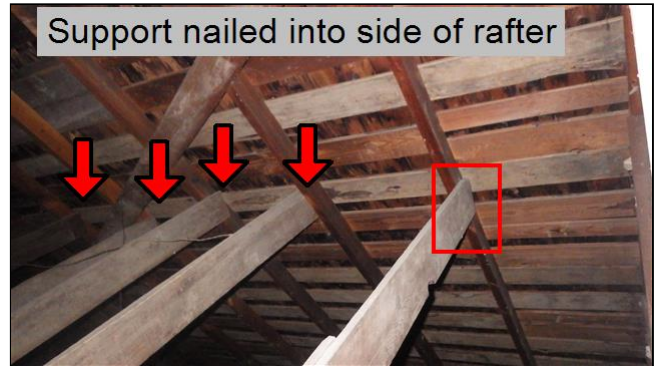
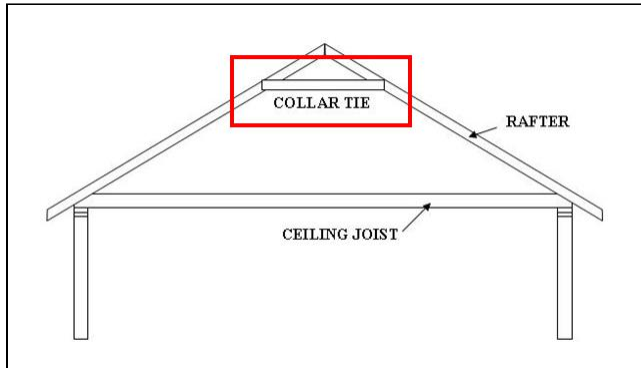
🏠 (1) The rafters appear to be under-sized or span is too far. The support for rafters is nailed into side of rafters and does not directly support rafters from underneath. Collar ties are missing from system. Some reinforcement may be needed to help maintain the stability of roofing system. For this reason, I recommend you contact a structural engineer or qualified contractor for a second opinion or correction as needed.

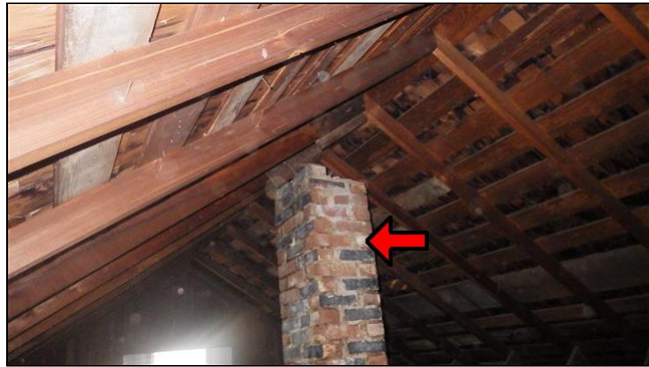
(2) There is an abandoned chimney in the attic towards the front of home in the attic. Structure appears stable. I recommend to remove as desired.

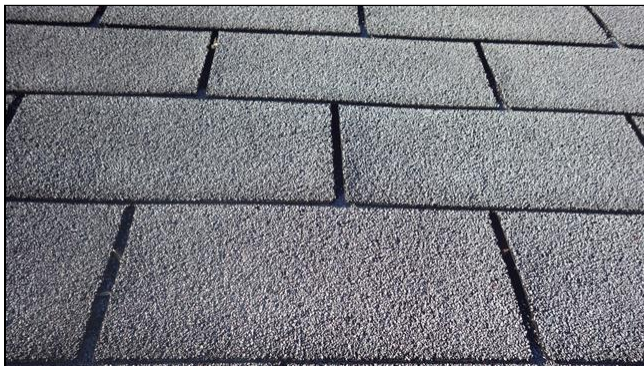
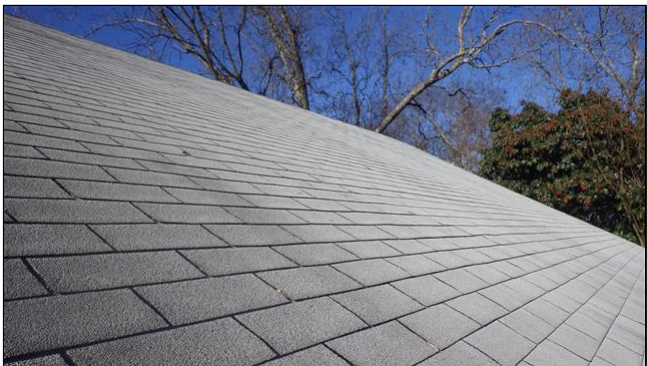
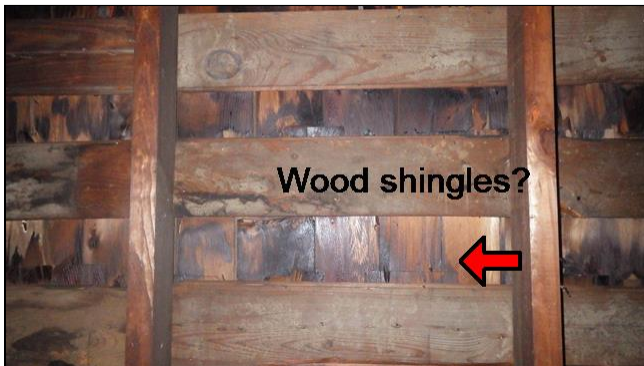
The shingles on this roof are in the condition of shingles that are near 10 years. The life expectancy for this type of shingle is 20 years.

The shingles appear to be installed over wood shingles and not a sheathing deck. In order to properly replace the shingles the wood shingles (if present) should be removed and a proper sheathing deck installed.

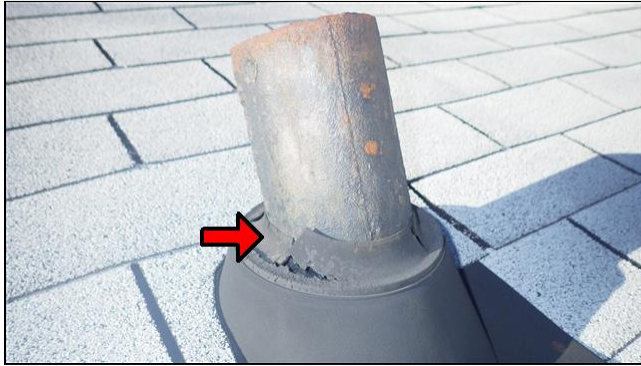
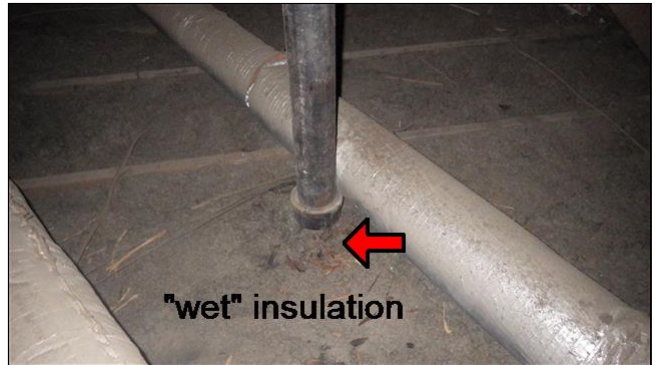
🏠 The plumbing vent pipes (through roof) vent flashing collar is cracked or damaged on the roof. This area can leak if not corrected. A qualified roofing contractor should inspect further and correct as needed. (All damaged boots may not be included in photos.)

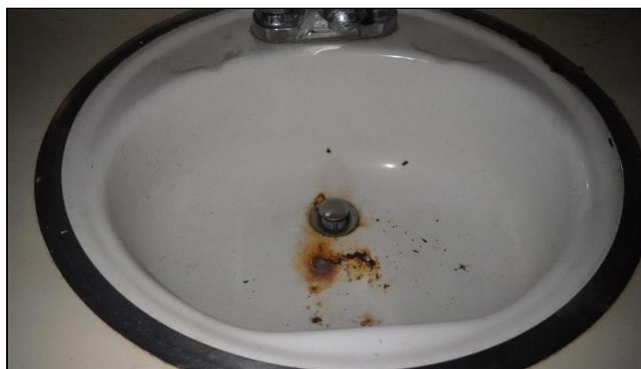
Due to water "off" at time of inspection plumbing fixtures were not inspected for function. There is visible rusting in bathroom sink. I recommend to repair or replace as needed or desired.

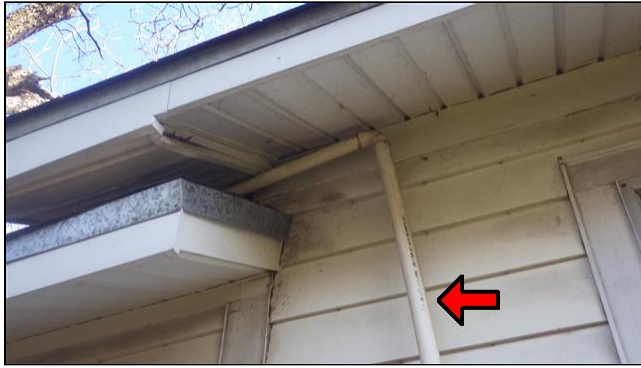
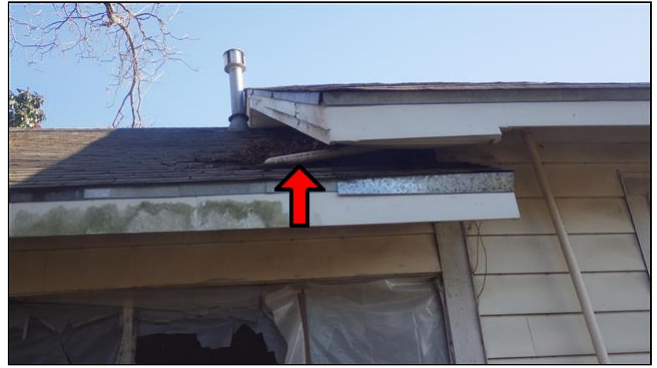
The plumbing vent pipe for kitchen should extend through roof for proper venting. It currently rest on the roofing at the rear of home creating a dam for leaves and debris on roof. I recommend a qualified contractor repair as needed.

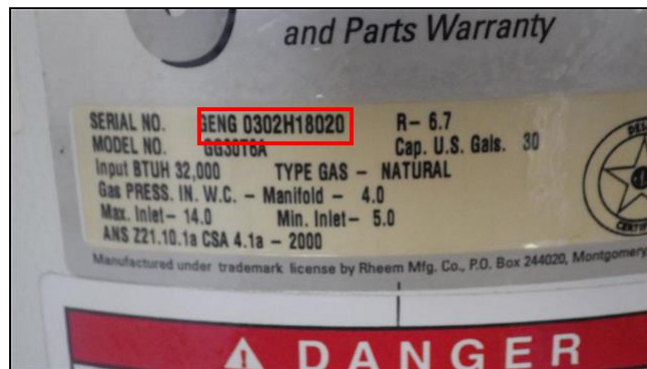
- 🏠 (1) The natural gas water heater is in the utility room. The unit is near 14 years old. The life expectancy for this type of water heater is 8-12 years. This is for your information.

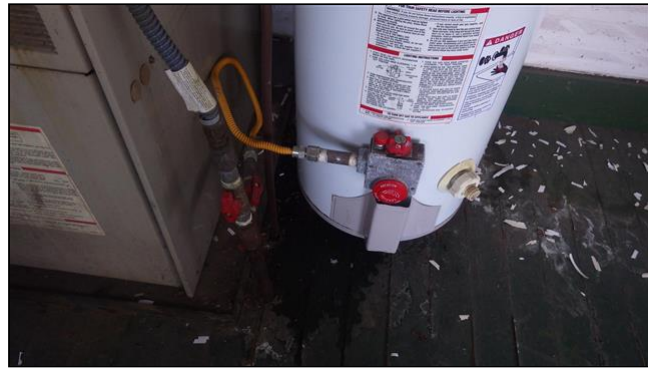
- 🏠 (2) The water heater leak water catch pan is missing. Should leaking develop at water heater it could also damage floor and wall finishes. A qualified person should repair as necessary.

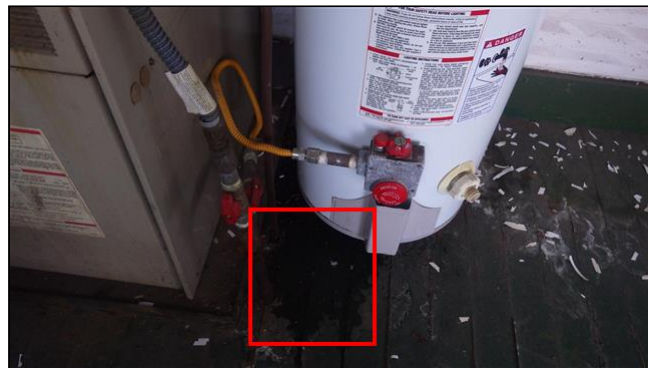
- 🏠 (3) There was active leaking at the water heater at time of inspection. I recommend to repair or replace using a qualified plumber.

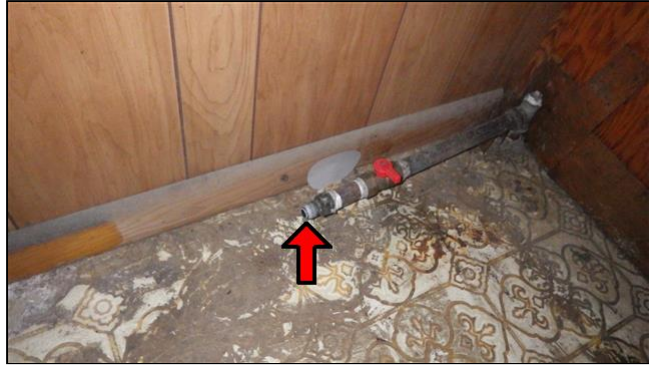
🏠 The natural gas line shut-off valve is missing a cap and can be turned on inadvertently at the range location in the kitchen. This is a safety issue and should be repaired. Please follow through to make sure the work is completed

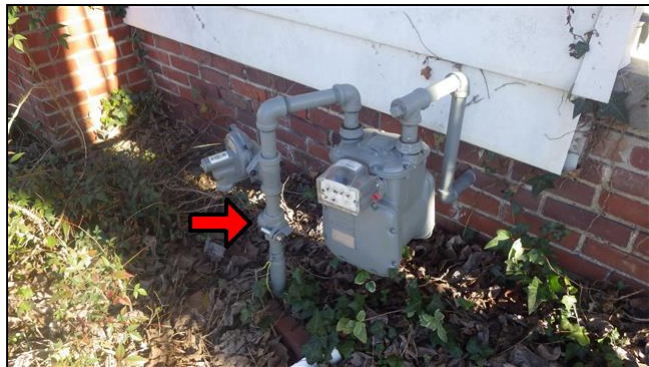
The main fuel shut off is at gas meter exterior right side (facing front). Valve was locked "off" and not tested for function. This is for your information.

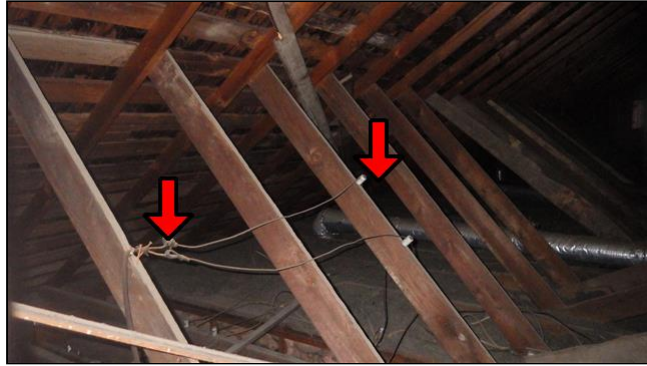
It appears that knob and tube wiring is still "active" in electrical system. Knob and tube wiring is beyond its life expectancy and should be replaced using a qualified electrician.

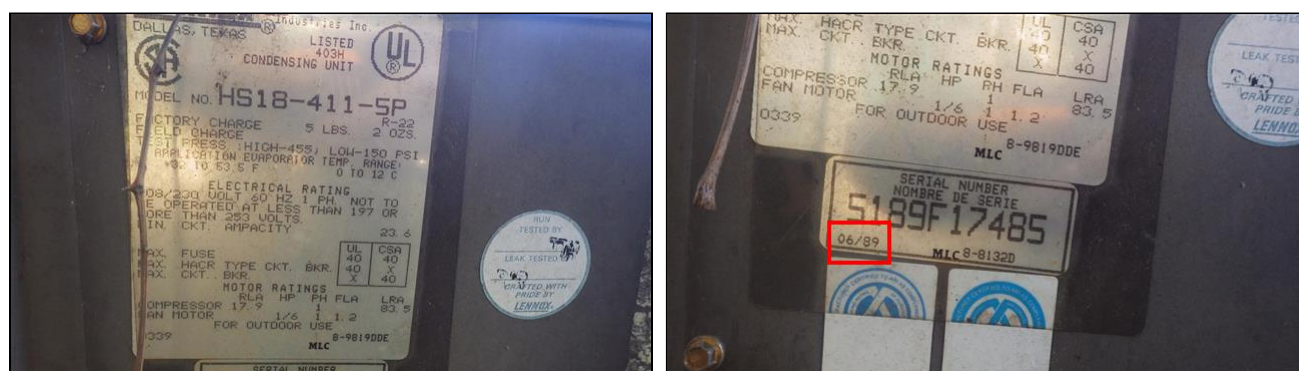
The air conditioner is near 28 years old. The typical life expectancy for this type of unit is 10-15 years. This is for your information. I recommend annual maintenance using a qualified HVAC technician.

Due to no electricity at time of inspection unit was not tested for function.

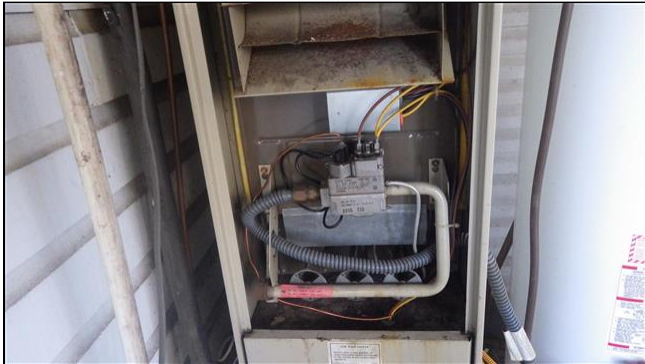
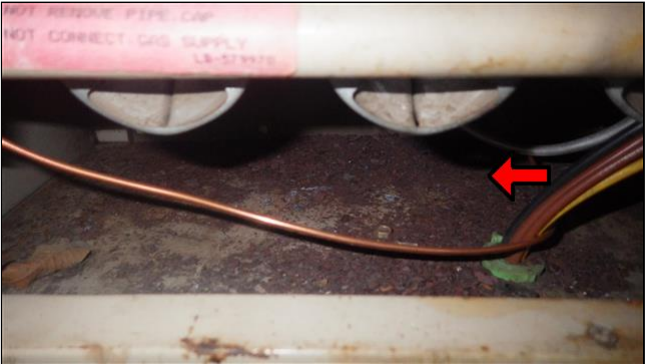
The natural gas central heating equipment appears beyond its life expectancy. This type of furnace has a typical life expectancy of 15-18 years. Heating equipment has considerable rusting at burn chamber. Heat exchangers are located inside the housing of units and are not readily accessible for inspection. I recommend further evaluation by a HVAC contractor. Replacement is likely needed.

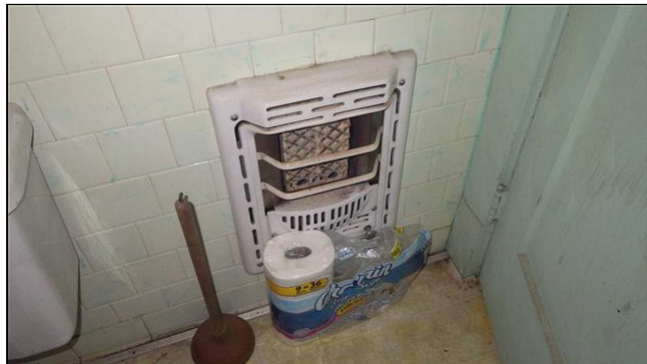
The gas stove at hall bathroom is not considered safe for use by most qualified tradesmen. I recommend removal or disconnection of heat source. This unit was not inspected.

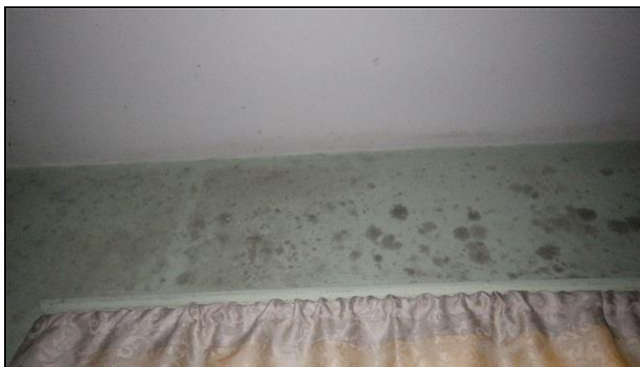
Signs of fungi growth are present on walls in the hallway bathroom. We did not inspect, test or determine if this growth is or is not a health hazard. The underlying cause is moisture or dampness. I recommend you contact a mold inspector or expert for investigation or correction if needed.

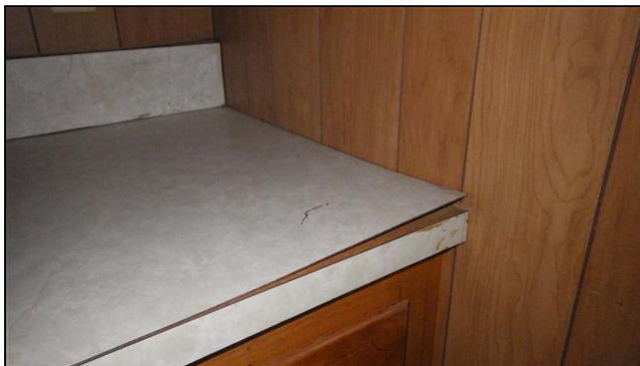
Laminated countertop is loose in areas. Damage may become worse if not corrected. I recommend repair as desired
